Subject: Department of Natural Resources Washington Geological Survey,
School Seismic Safety Assessment Project, Contract No. AE 410 -
Seismic Evaluation for **Centralia School District**

1. Edison Elementary School, Main Building

1.1 Building Description

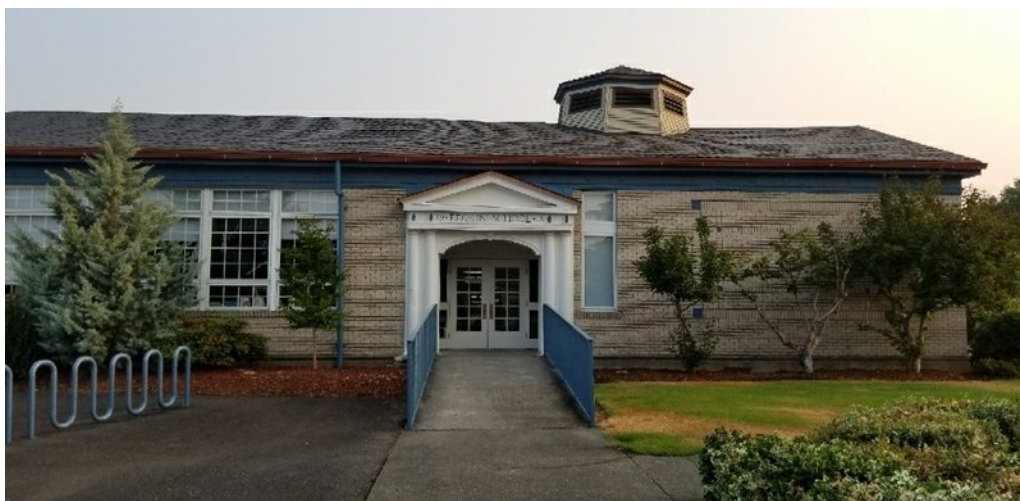
Figure 1-1. South entrance

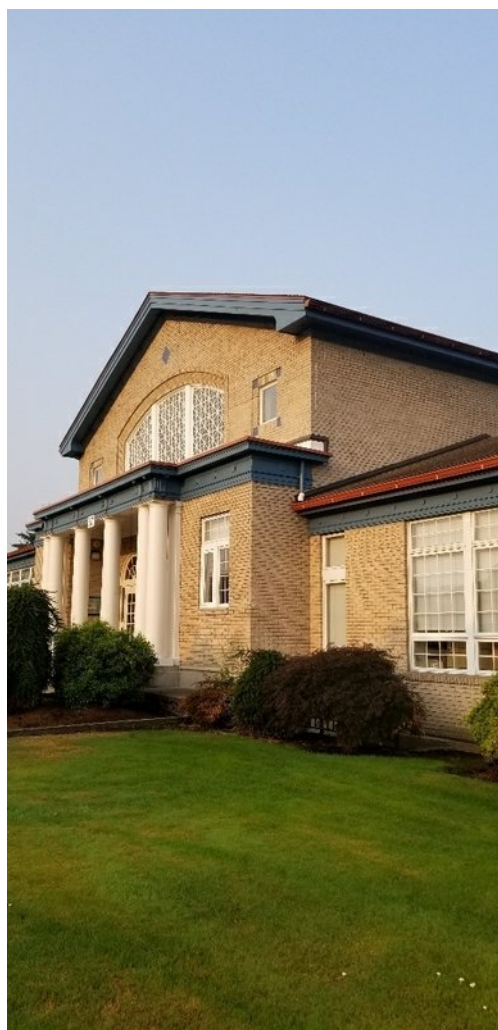
Figure 1-2. Main entrance

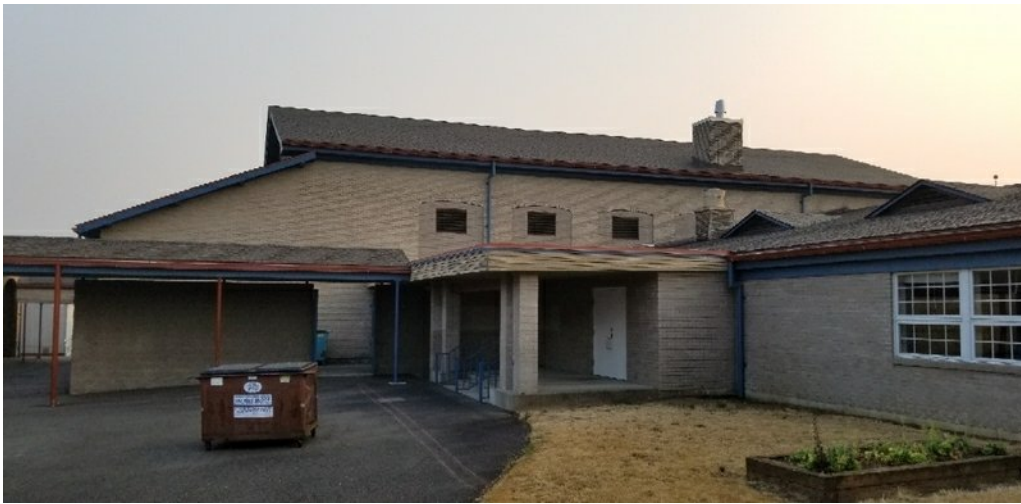
Figure 1-3. Southwest elevation of the gym/auditorium

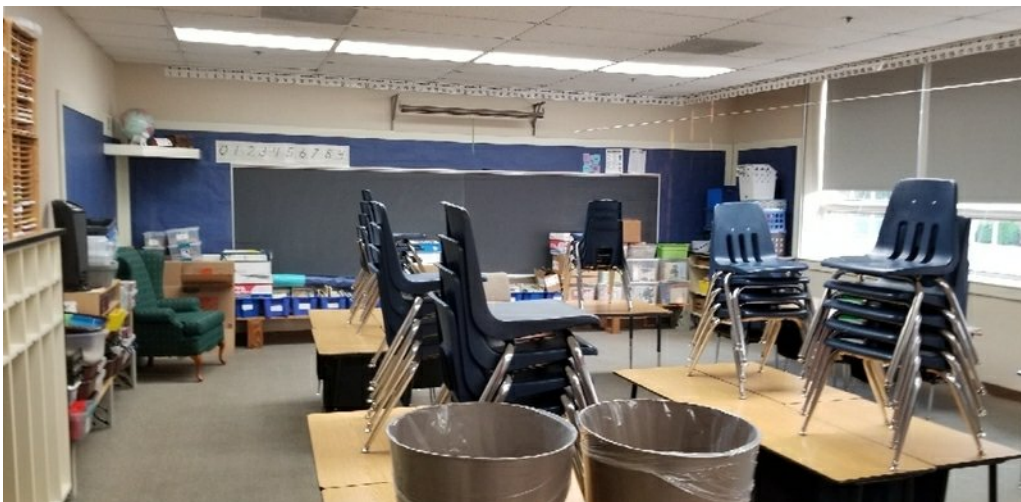
Figure 1-4. Typical classroom layout

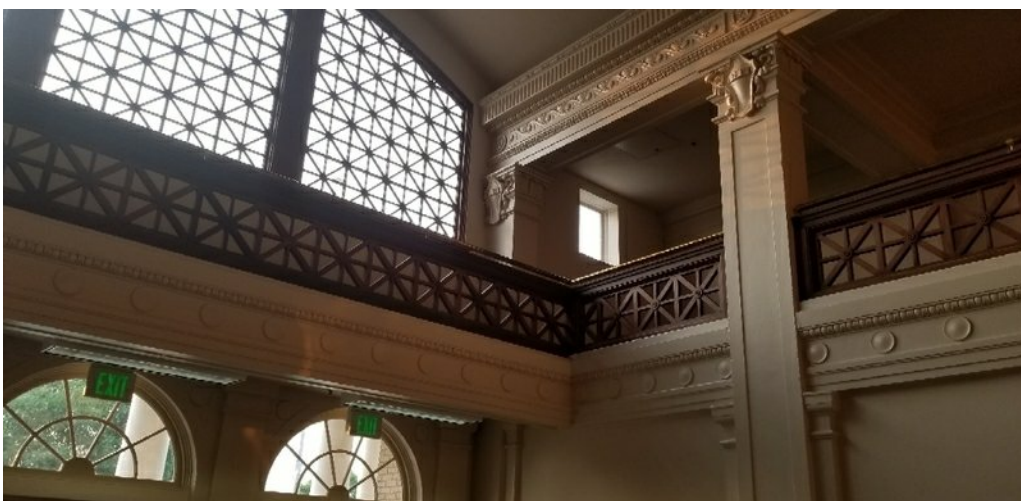
Figure 1-5. View of the lobby mezzanine at the main entrance

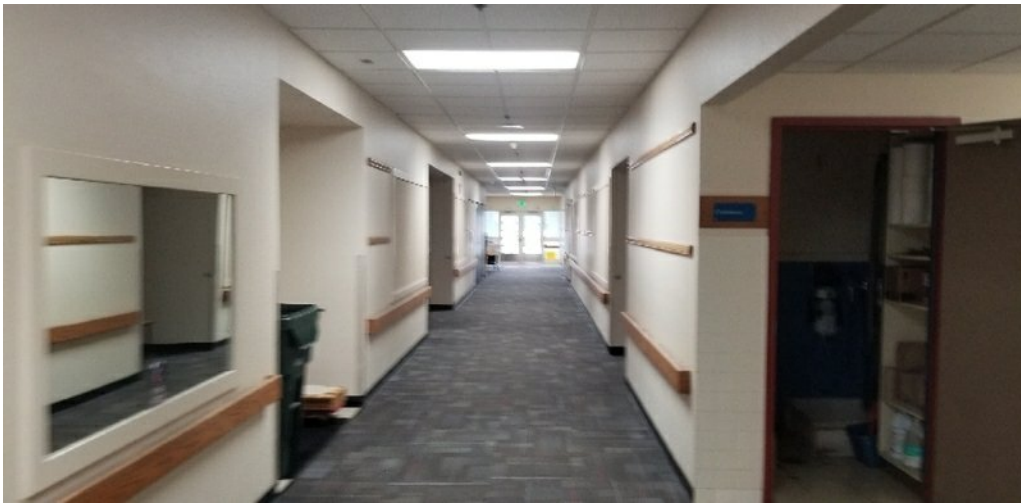
Figure 1-6. Typical hallway

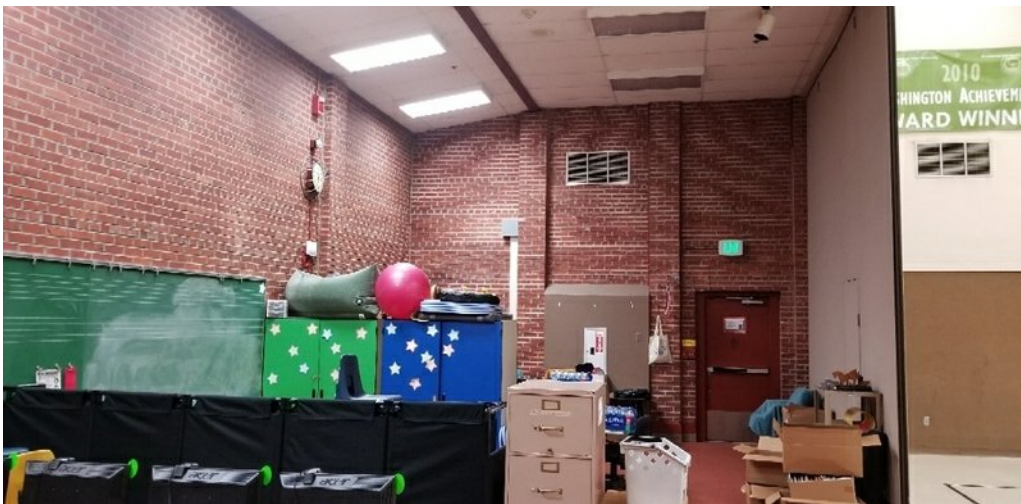
Figure 1-7. 1957 music room addition to the backside of the the gym/auditorium

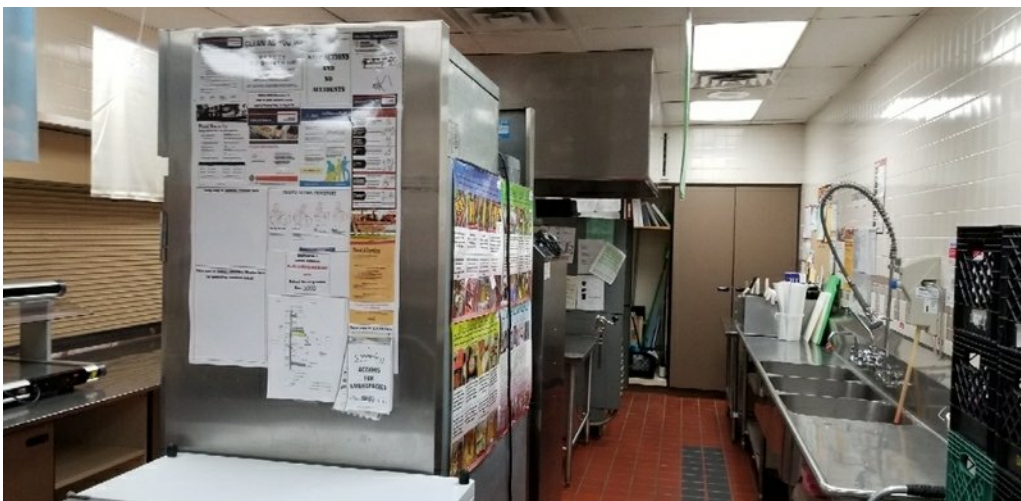
Figure 1-8. Kitchen

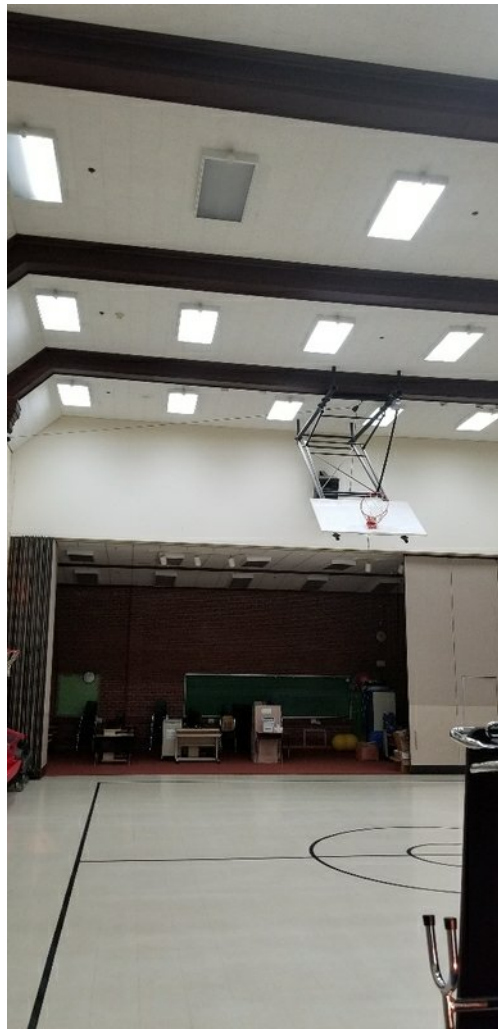
Figure 1-9. Interior view of the gym/auditorium facing the 1957 music room addition (beyond)

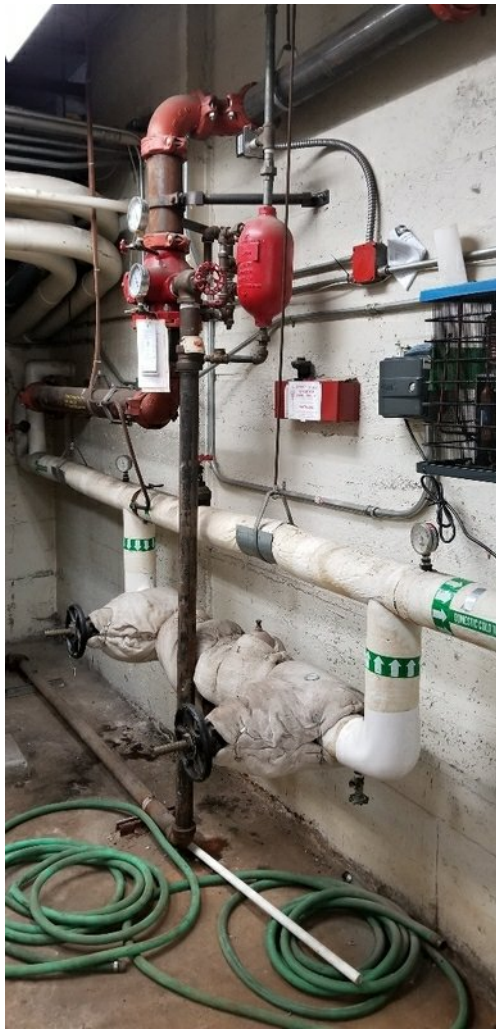
Figure 1-10. Piping in the basement mechanical space
